GARY GIBSON, JR. and SHAWNA)	CASE NO. 8:16-cv-296
GIBSON, Husband and Wife,)	
)	
Plaintiffs,)	
)	DEFENDANTS DISCLOSURE OF
vs.)	EXPERT TESTIMONY
)	
BRIESON JENSEN and FARMERS)	
CO-OPERATIVE,)	
)	
Defendants.)

Preliminary Collision Reconstruction & Analysis

Gary Gibson, Jr. and Shawna Gibson v. Farmers' Co-operative
United States District Court, District of Nebraska
Case No.: 8:16-cv-296
April 3, 2017

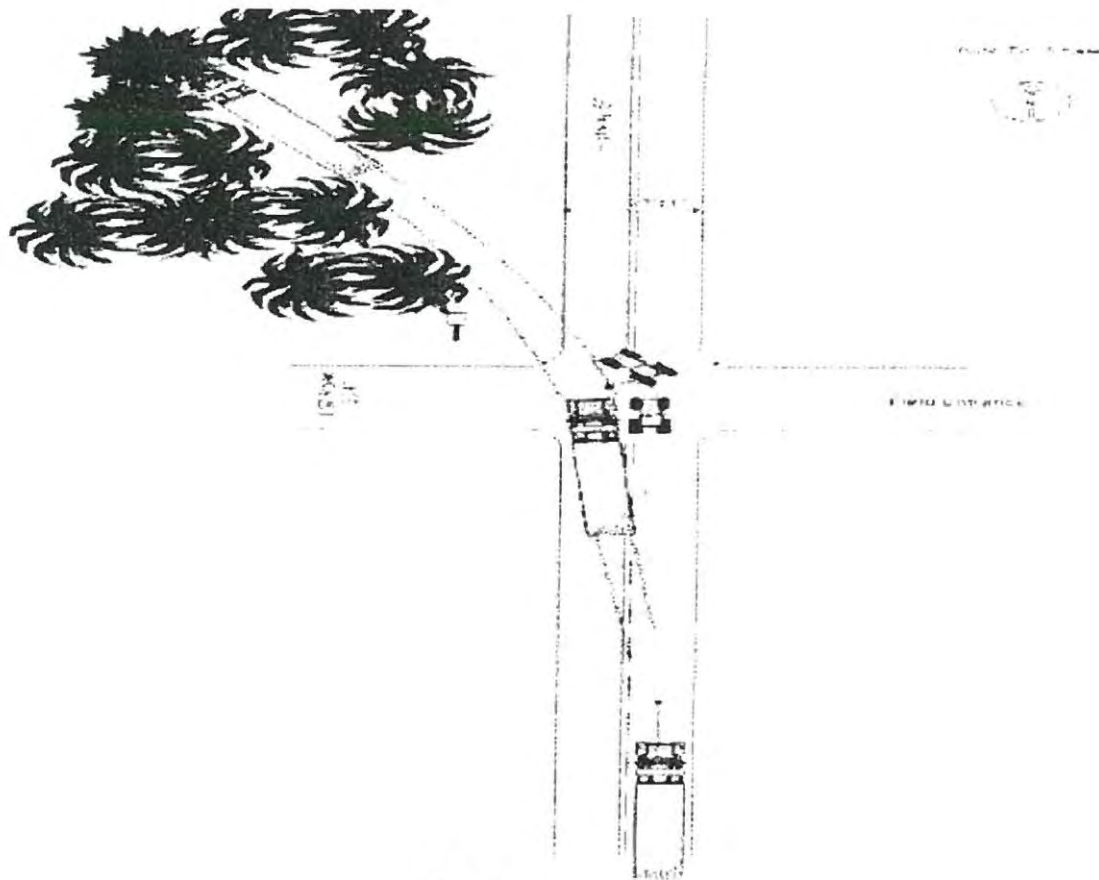
That diagram, which has been displayed as Figure 1 on the following page, illustrated and summarized the movements of the commercial motor vehicle and the farm equipment, based upon the physical evidence and information developed by the investigating sheriff deputy during his investigation of the incident.

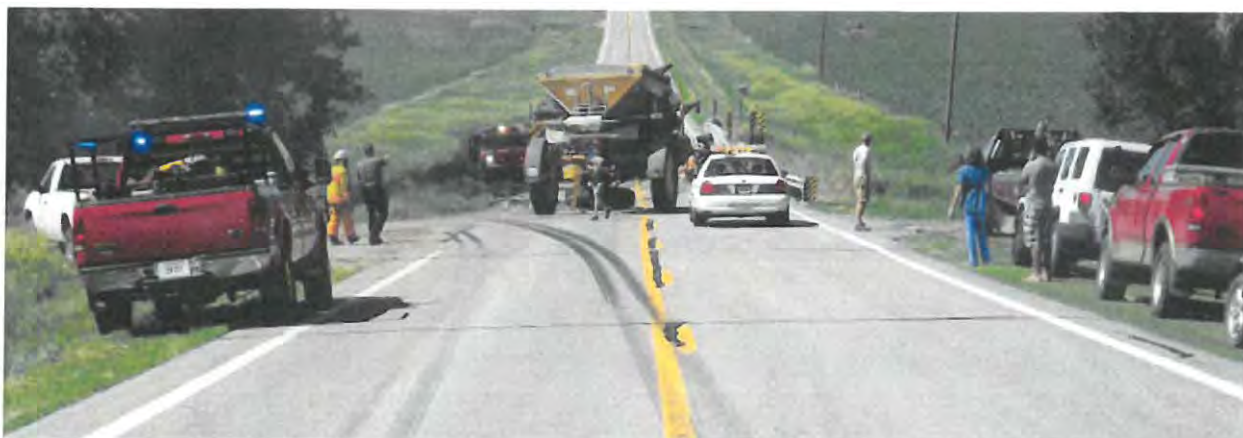
Figure 2 – view looking north toward collision area

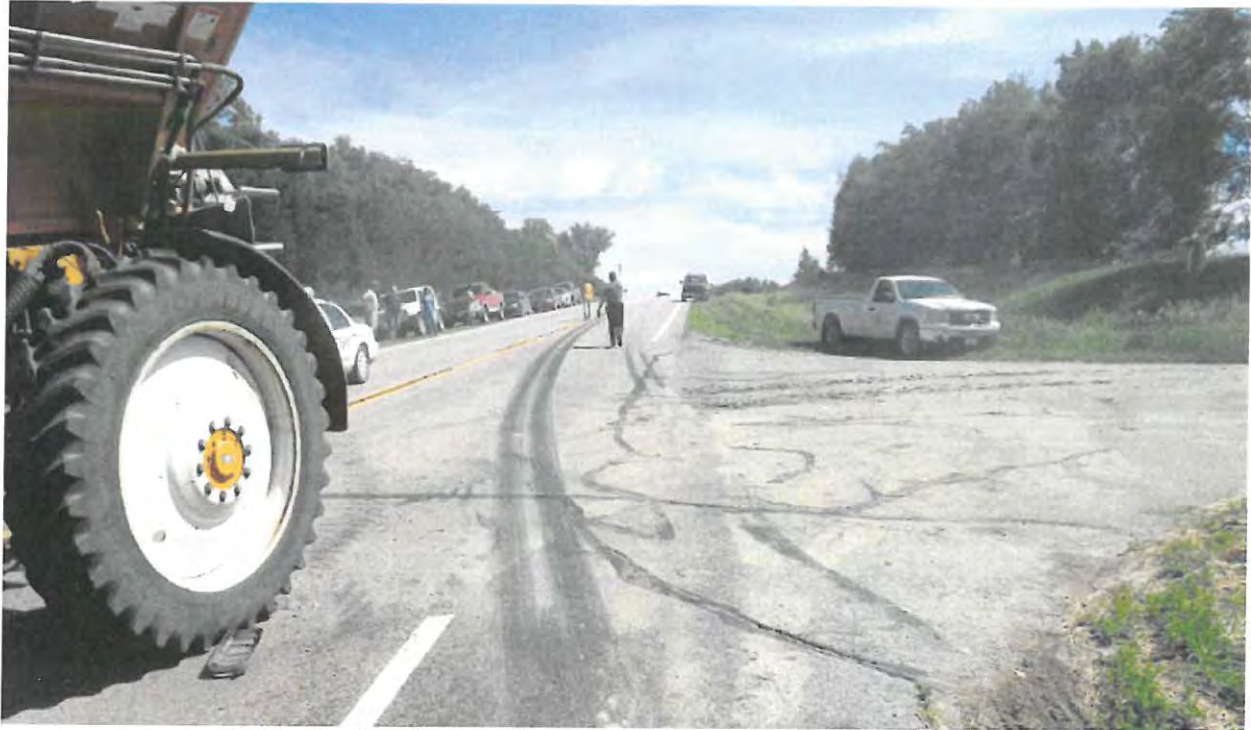
Figure 3 – looking south toward hillcrest from intersection area

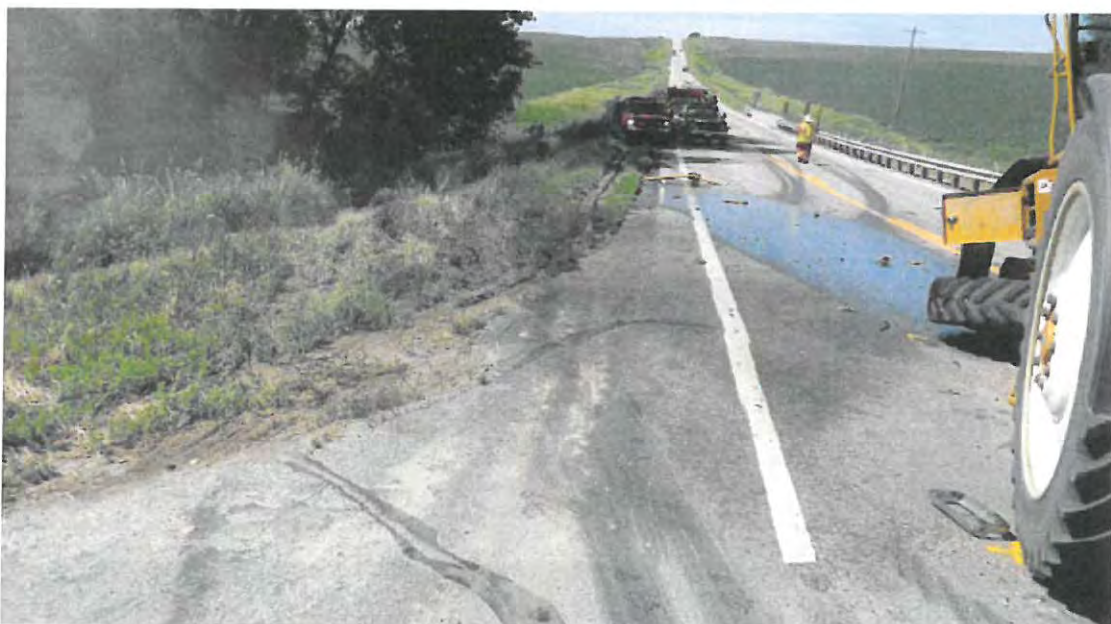
Figure 4 – looking northwest from intersection toward area where the truck-trailer came to a stop within the trees

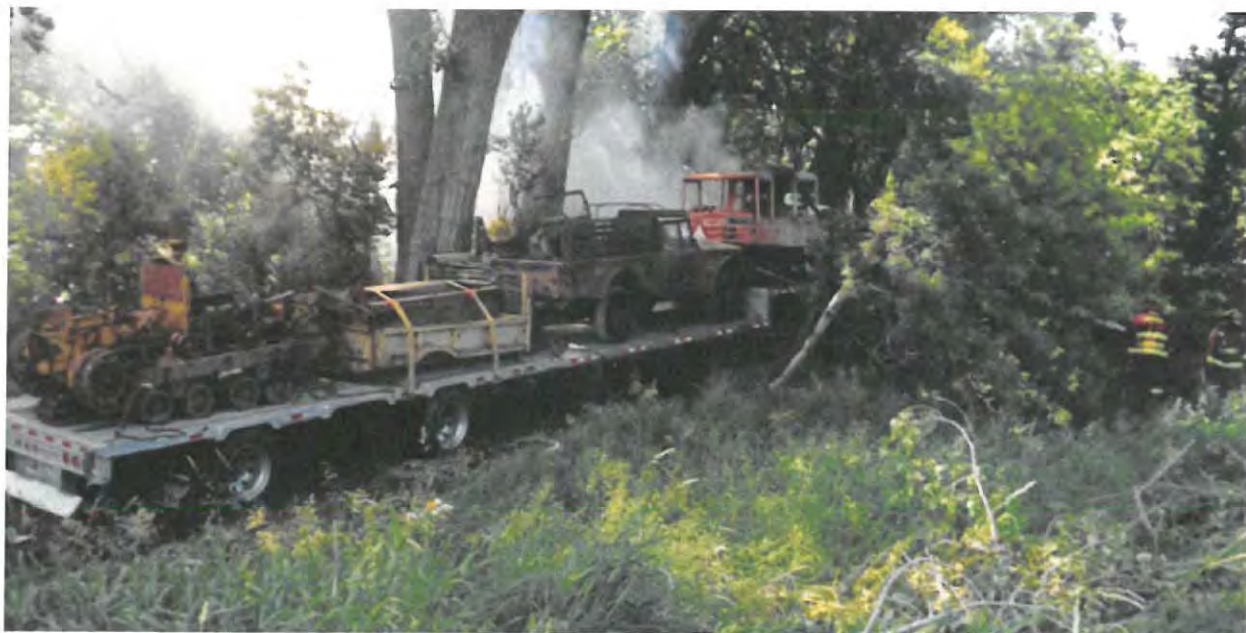
Figure 5 – closer view of area where truck-trailer came to a stop

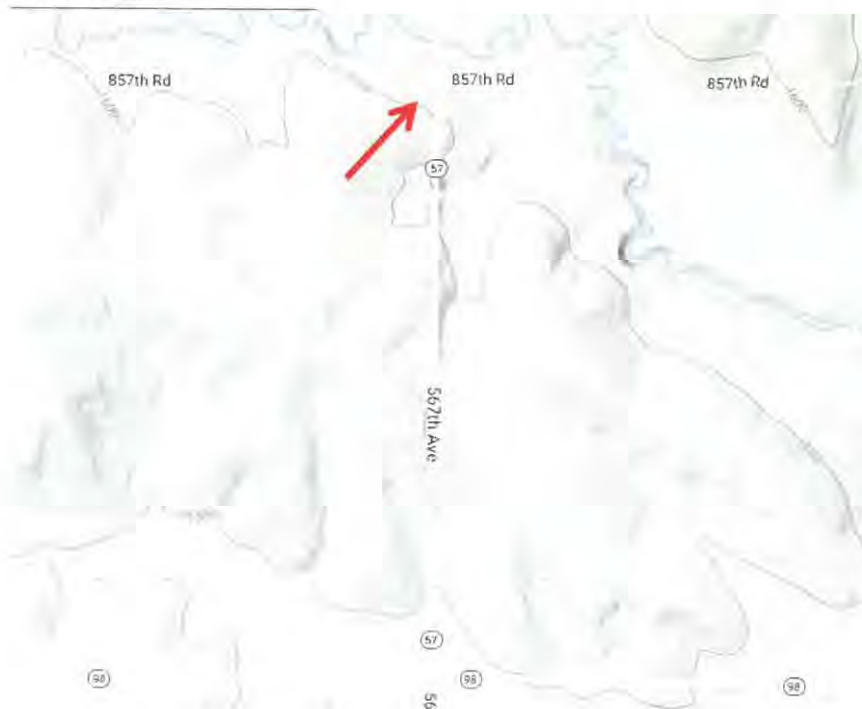
The topography in the area was obviously non-uniform, with some minor-to-moderate variations in terrain elevations. Research of the land surface data, based on topographical mapping obtained from the U.S. Geological Survey, detailed the frequent variations of the land surfaces surrounding the accident location. That information was compared to the information developed during the on-scene investigation, and to the photographic documentation of the area surrounding the collision location, and was found to be consistent.

Figure 7 – topographical depiction of terrain features

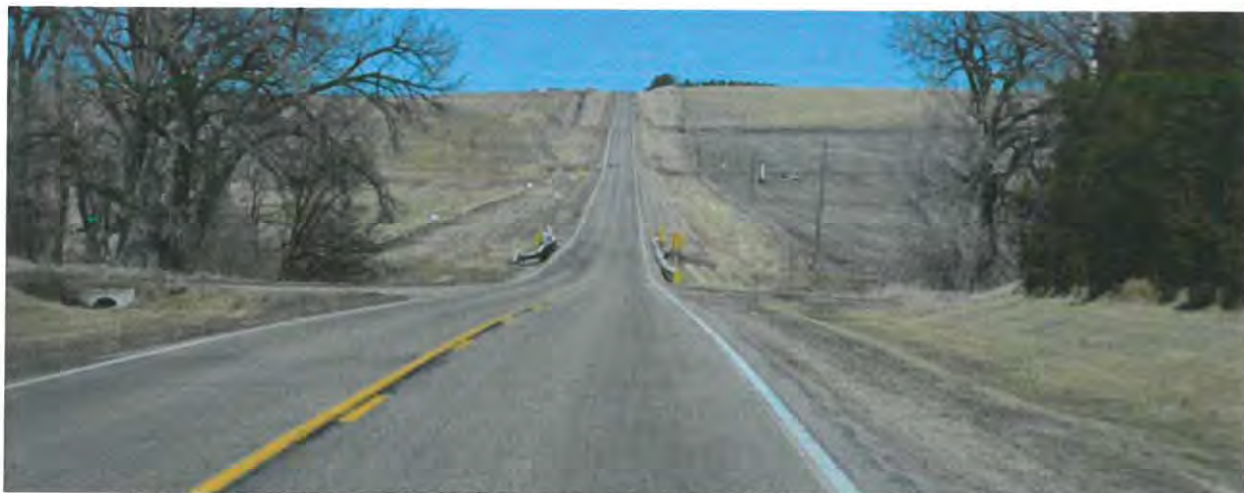
Figure 8 – looking north toward intersection from northbound lane of Highway 57

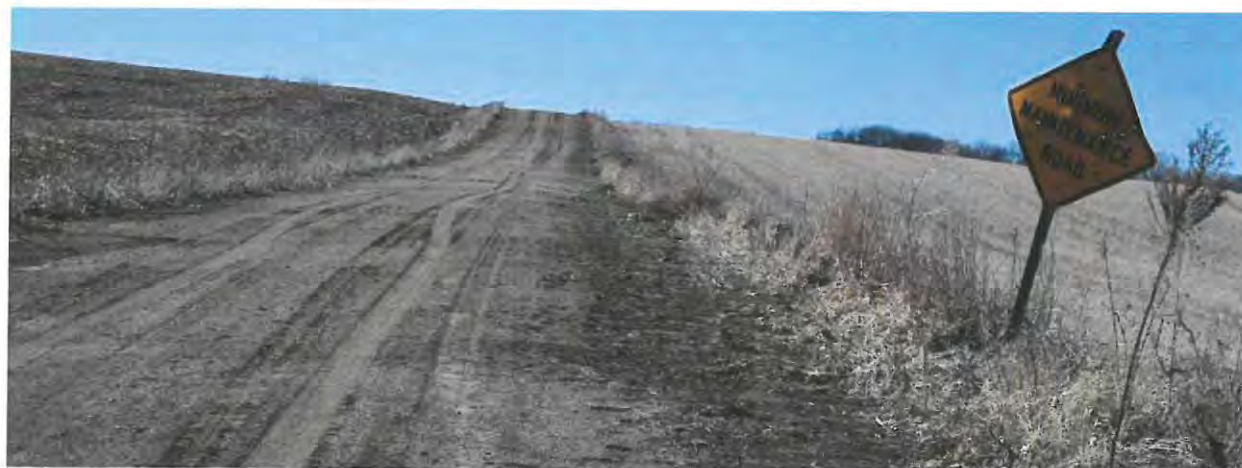
In the area of the accident, a local road identified by signage as *Road 857*, connected with State Highway 57 in an approximate 90-degree angular alignment. During the on-site documentation process, it was observed that Road 857 was comprised of natural soils, and only serviced various farm fields and related property. Signage associated with that roadway indicated the road was classified as a “minimum maintenance road” or field access road, as the infrastructure, safety features and width dimension farther west did not meet the common minimum standards of an “unpaved typical gravel road”. Apparently, the county filed a request with NDOR to obtain that classification. A view of that unimproved local road has been shown below as Figure 9.

Figure 9 – looking west on the field/minimal maintenance road

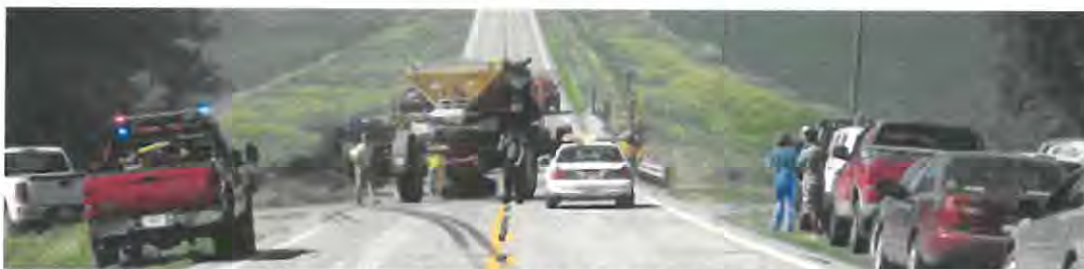
Figure 10 – view looking north on Highway 57

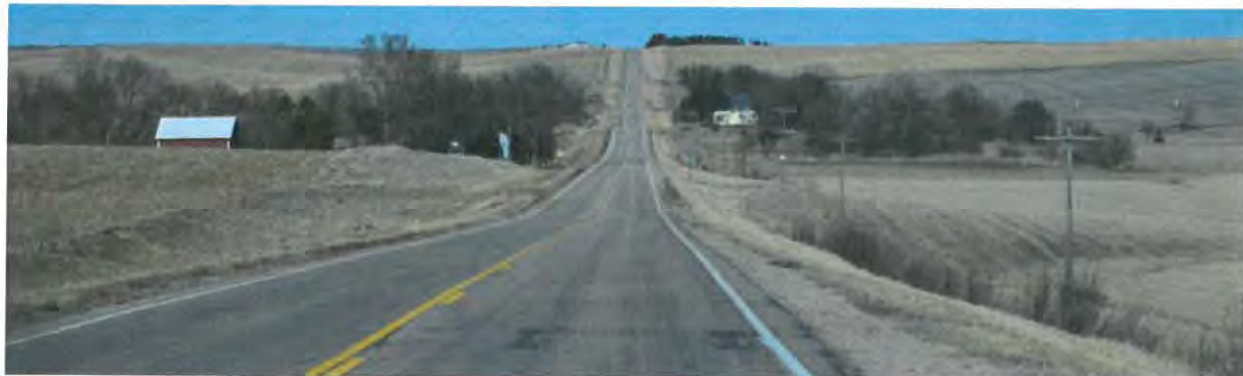
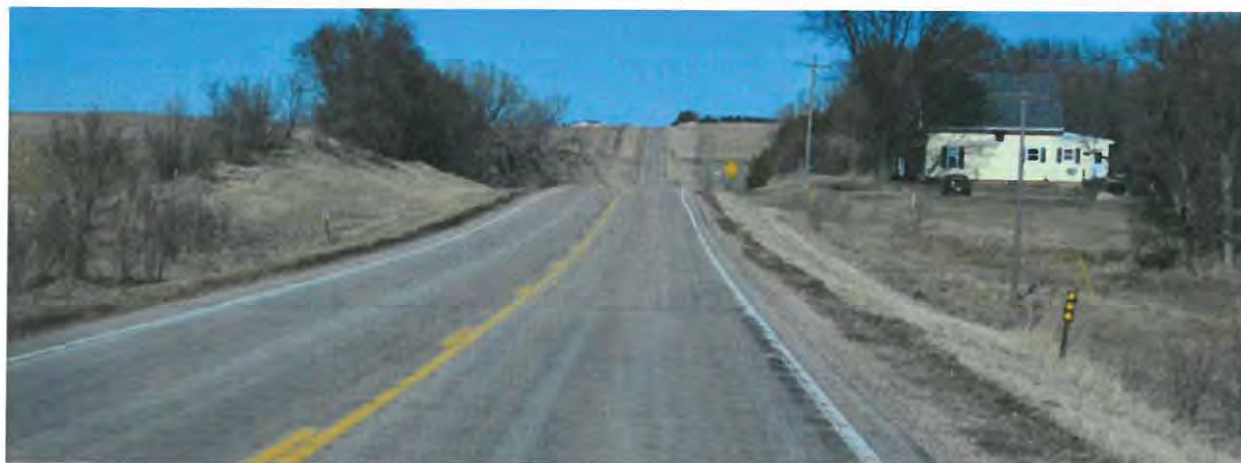
The appearance of some of those pavement markings and lane configurations can be viewed within some of the photographs taken during the on-scene investigative activities conducted in March 2017; two of those photographs are shown below as Figures 11 and 12. Research data indicated that the striping pattern within that segment of Highway 57 had not changed since the time of the accident and that yearly painting of the pavement surface markings was part of the normal roadway maintenance procedure by NDOR.

Figures 11 and 12 – views looking north on State Highway 57

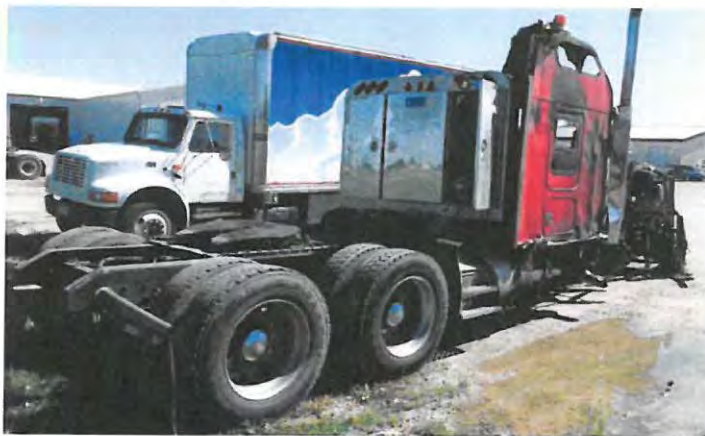
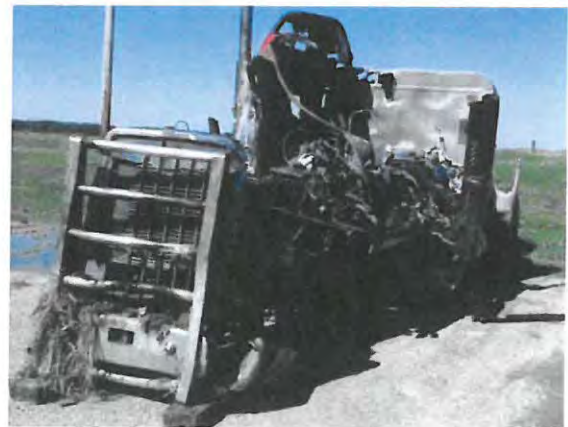
As evident within the photographs, a significant number of components were damaged during the collision events, as well as during the subsequent fire that consumed the forward portion of the Kenworth® W900. A majority of that collision-related structural damage was within the forward portions of the heavy-duty truck tractor.

Figures 13 through 15 – views of the damaged Kenworth® W900

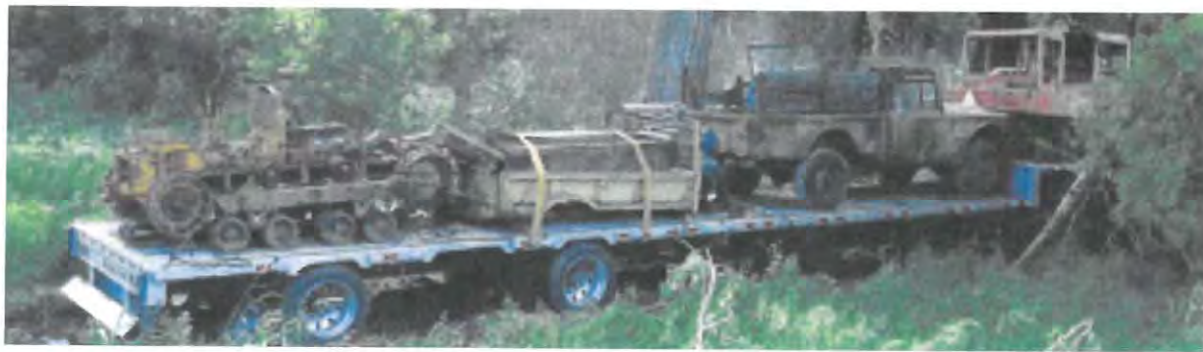
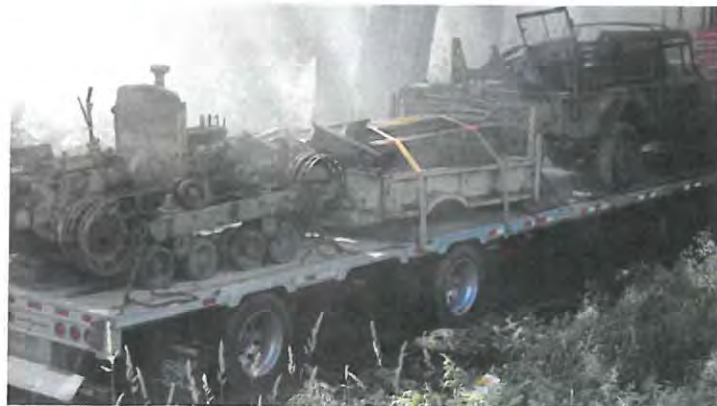
The 2013 Manac® step-deck semi-trailer involved in the crash had a twin axle, with a spread formation, semi-trailer. The heavy-duty, low-profile semi-trailer was hauling an assortment of antique military vehicles. There was no indication that the semi-trailer or its load sustained any substantial physical damage during the crash event.

**Figures 19 and 20 –
views of the Manac®
step-deck semi-trailer**

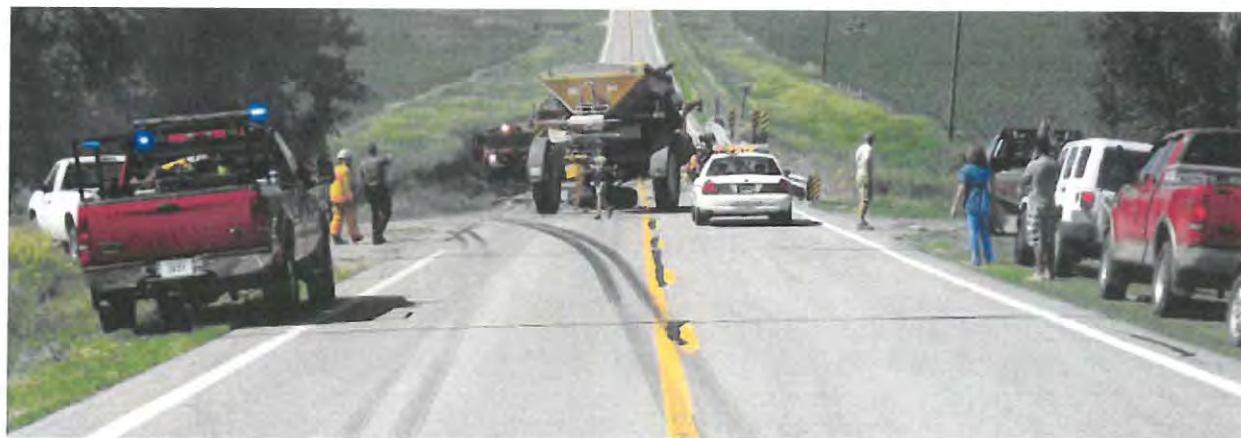
Figure 26 – view of the RoGator® at the accident scene

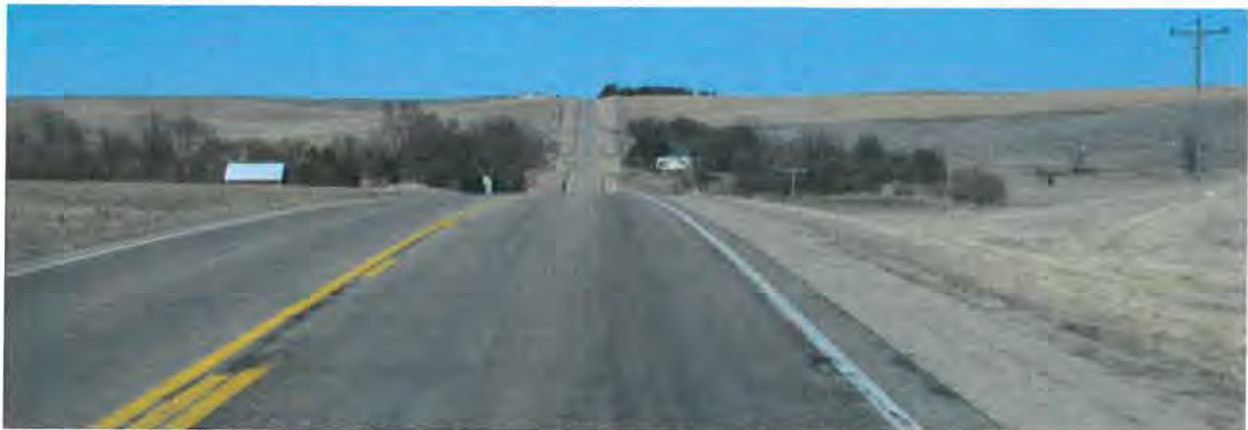
During an examination of the northbound approach to the crash location, it was determined that a line-of-sight from a large hillcrest, just north of the Nebraska State Highway 98 and 57 intersection, to the next large hillcrest at the horizon line was possible, with that distance being over one mile. Additionally, the view toward the north, to the Road 857 intersection area, was also possible. That distance to the intersection was determined to be approximately 2,975 feet, as represented within the photograph identified as Figure 27 below. The timing of northbound truck traffic traveling between that hillcrest location and the next smaller hillcrest area, just south of the intersection with Road 857, was determined to be between approximately 25 to 30 seconds.

Figure 27 – view toward the north on State Highway 57

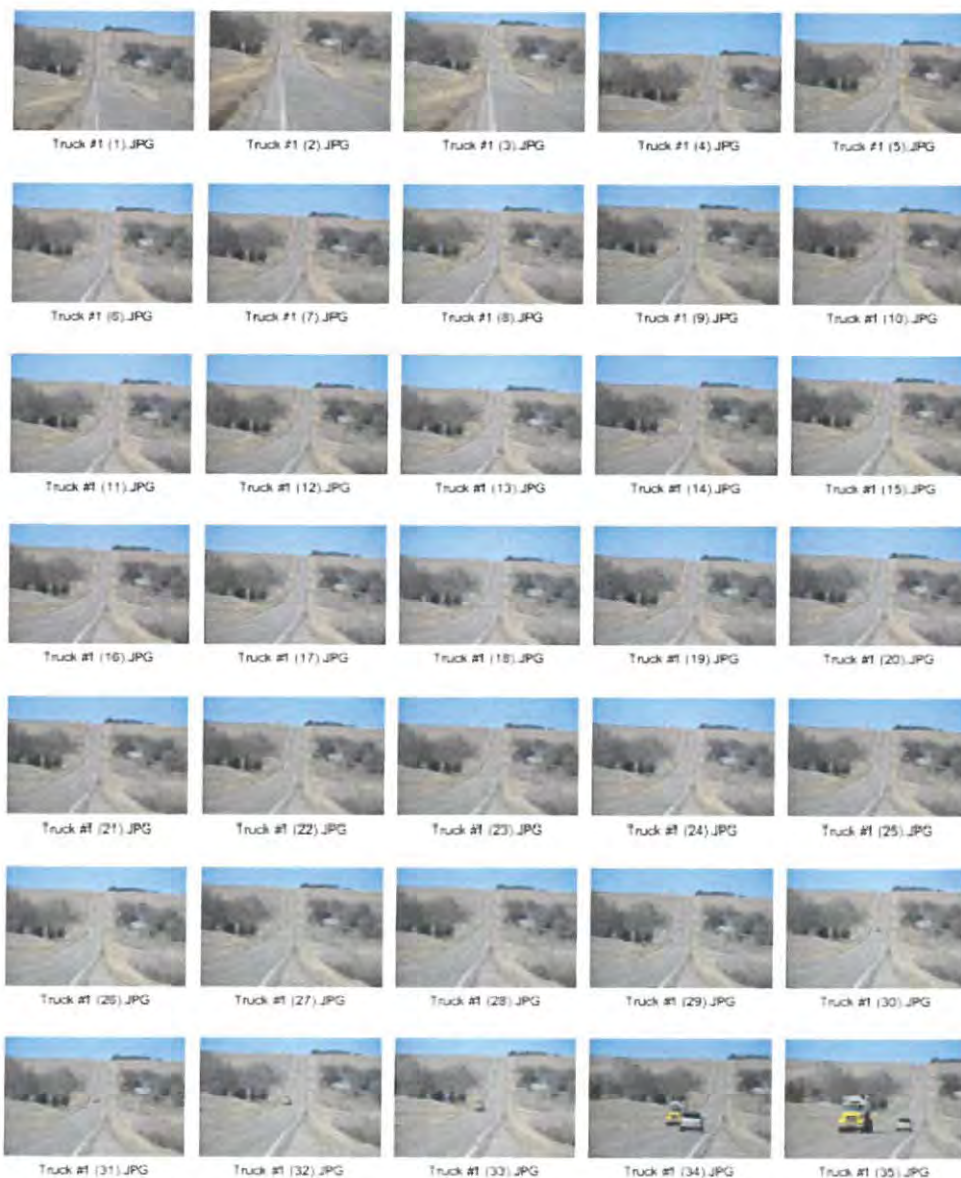
Figure 28
 (replicated in
 Appendix B)

trailer's overall height. Forensic work conducted at the scene of this traffic collision, as well as within the northbound approach to the collision location, indicated that the minimal terrain elevation to the south of the intersection would not have been significant in preventing, inhibiting or delaying detection of the presence of the AGCO RoGator[®] farm implement as it progressed from the smaller hillcrest down towards the north and towards the intersection of Road 857. An example of that forensic work has been displayed within Figure 28 below.

The following four pages (Pages 44 thru 47) duplicate Figure 28 within the report and provide an enlarged view of the line-of-sight that was discussed.

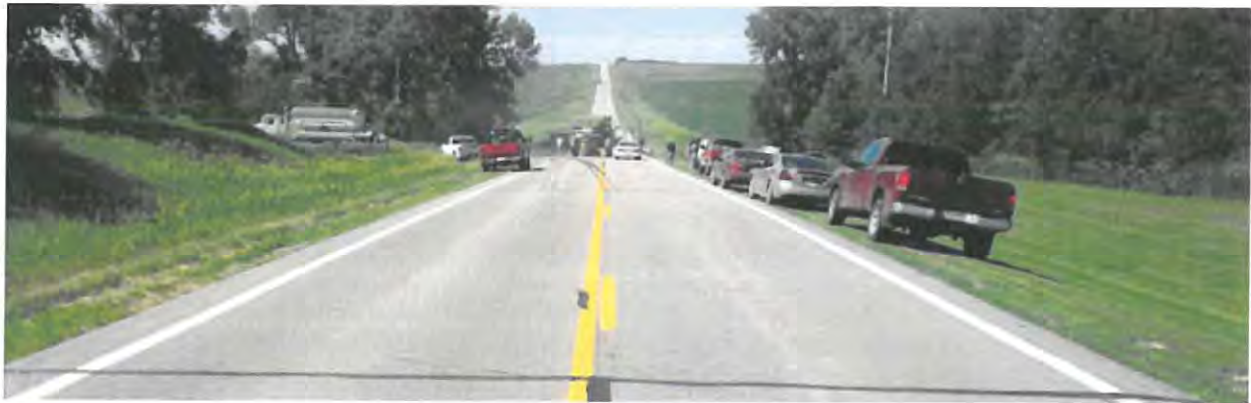
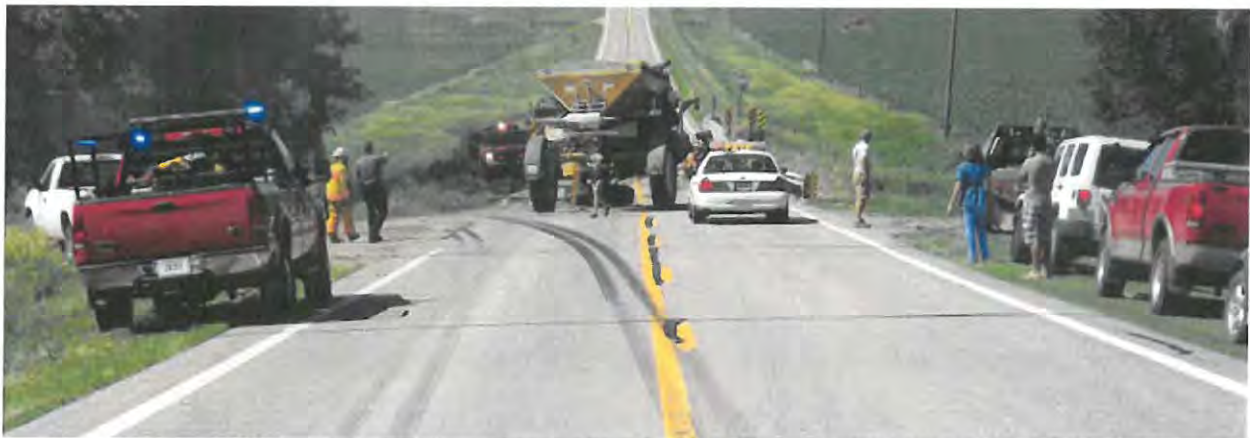
Figures 29 and 30 – photographs taken by the Sheriff Department during their investigation

Figure 29, in particular, provided some significant perspective of the grade of the hill located south of the collision intersection. Additionally, the height differential between the AGCO RoGator[®] farm equipment and the adjacent Ford[®] Crown Victoria police vehicle can be viewed.

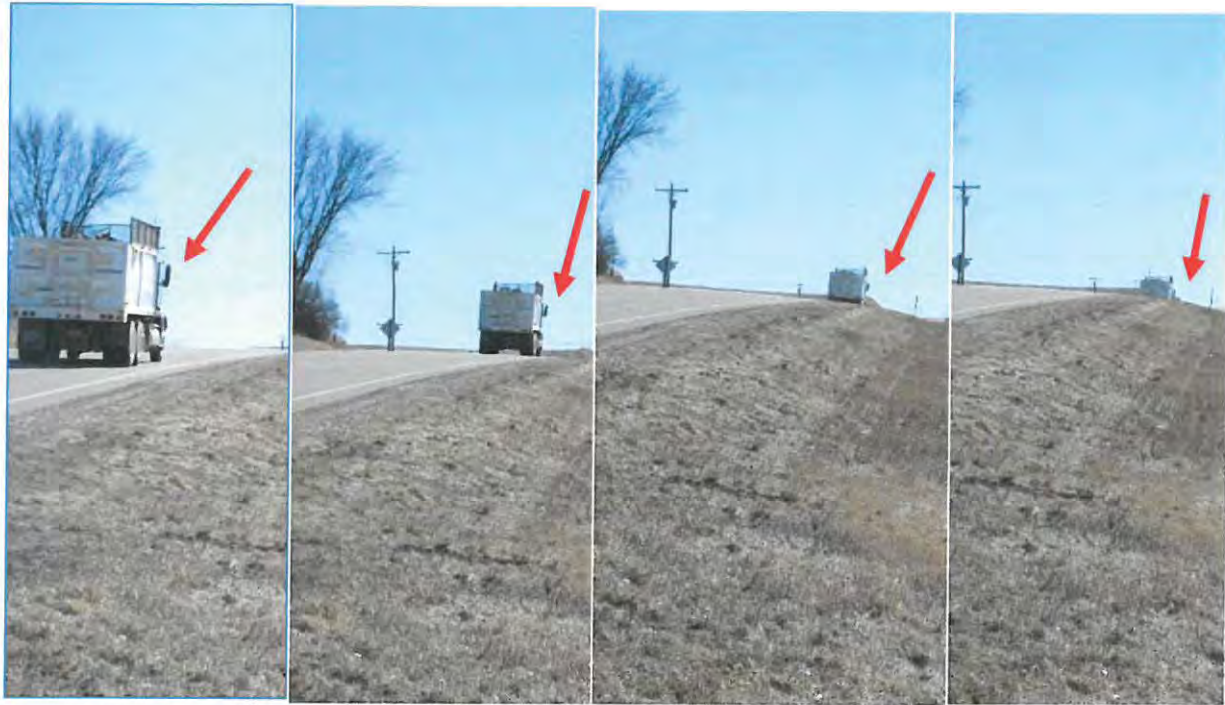
Figure 31 – compilation of photos showing southbound truck

Figure 31 illustrated the minor nature of the terrain differential just south of the intersection with Road 857. While standing on the west side of Road 857, with a camera position at just less than 6 feet above the ground, the right, outside rear-view mirror on the Class 8 straight truck can be seen for a substantial distance as the truck progresses toward the south. Figure 32, which also displayed a few images from a photographic sequence, illustrated the same minor terrain differential, relative to an approximate 6 foot camera height within the southbound lane of Highway 57.

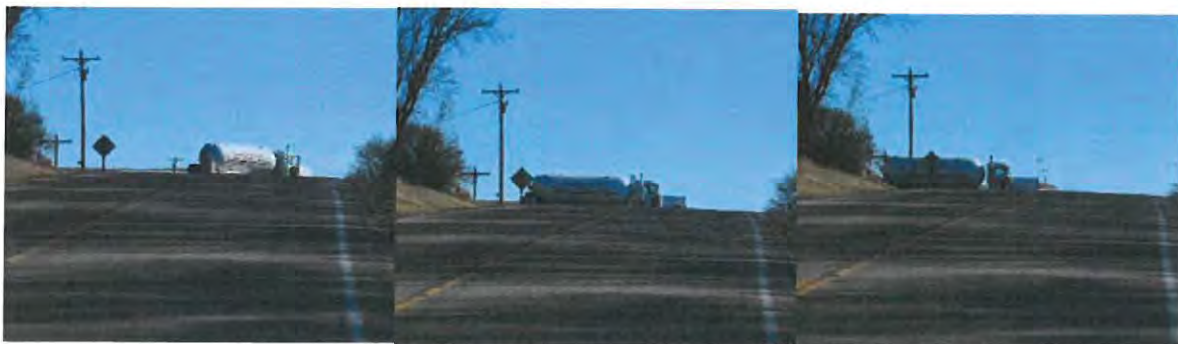
Figure 32 – Class 8 truck backing into a driveway more than 600 feet from the intersection

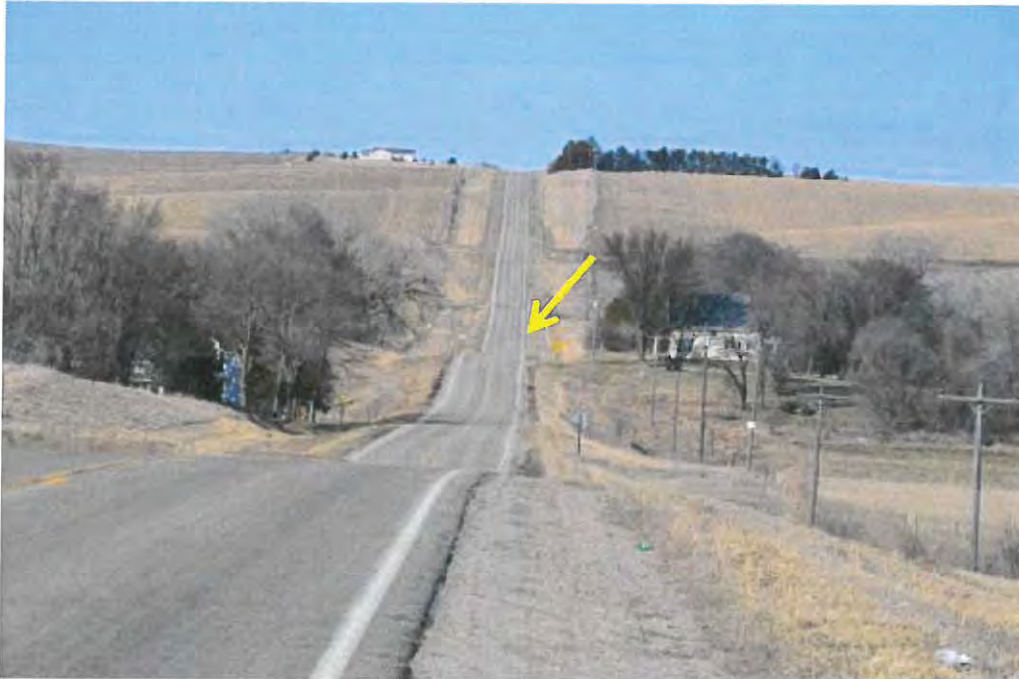
Figure 34a – approximately 2,975 feet from intersection; arrow shows vertical marker

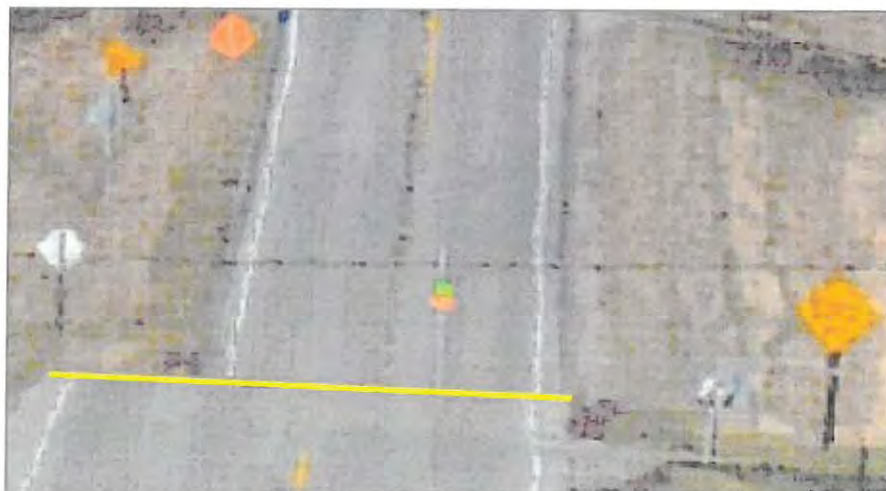
**Figure 34b – close-up view of same marker at 2,975 feet
with horizon line marked in yellow**

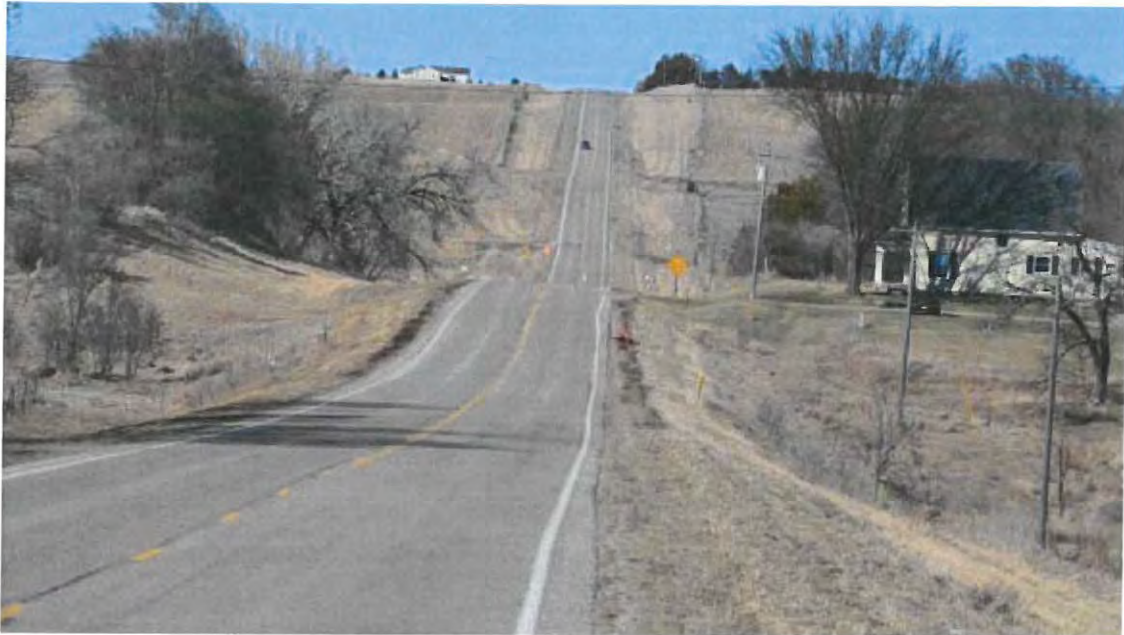
Figure 35a – approximately 1,850 feet from intersection

As evident with Figures 35a and 35b, at a distance of between approximately 1,800 feet and 795 feet from the eventual area of impact, a substantial quantity of the rear vertical structure (as much as 4.5 feet of the overall height of 12.5 feet) of the AGCO RoGator® farm implement would have been easily detectable and recognizable as farm equipment positioned on the highway. At all points closer than approximately 795 feet, a majority of the entire rear vertical profile of the farm implement would have been detectable and identifiable. Examples of that substantial vertical distance have been displayed in the photographic evidence incorporated below.

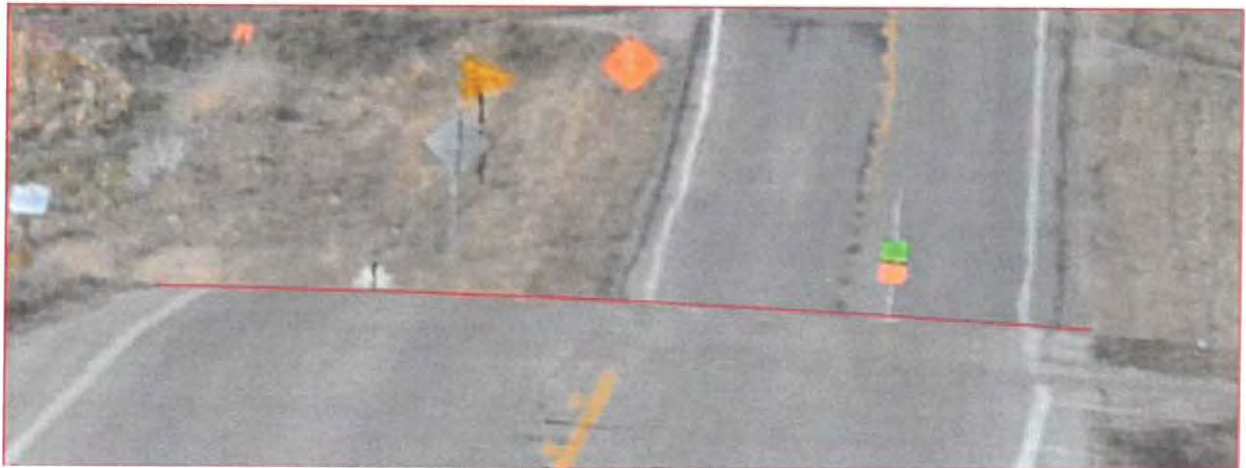
**Figure 35b – close-up view of vertical marker
with horizon line marked in red**

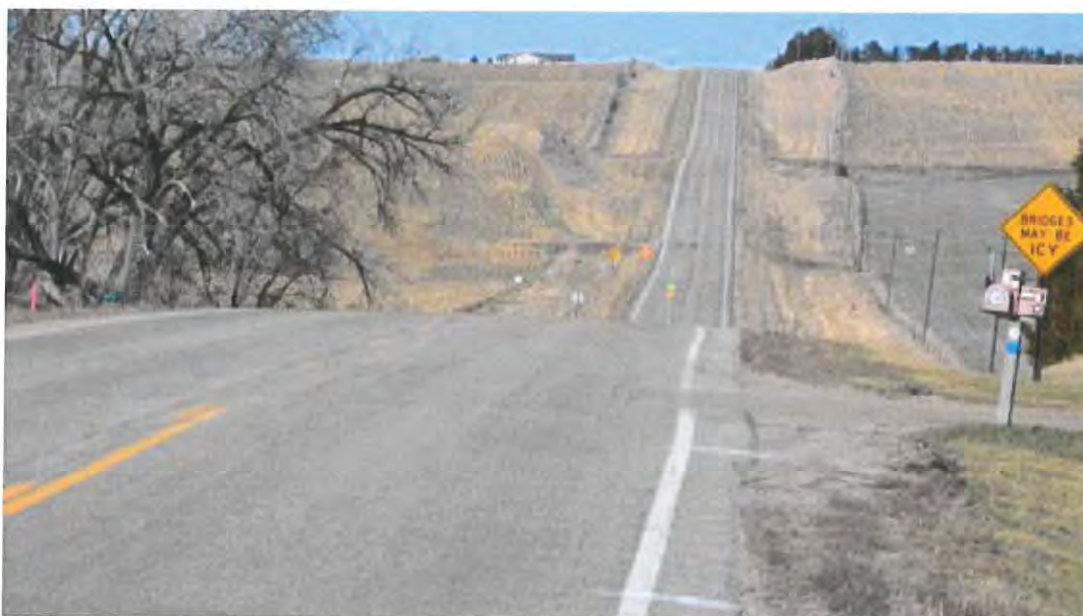
Figure 36a – approximately 795 feet from intersection

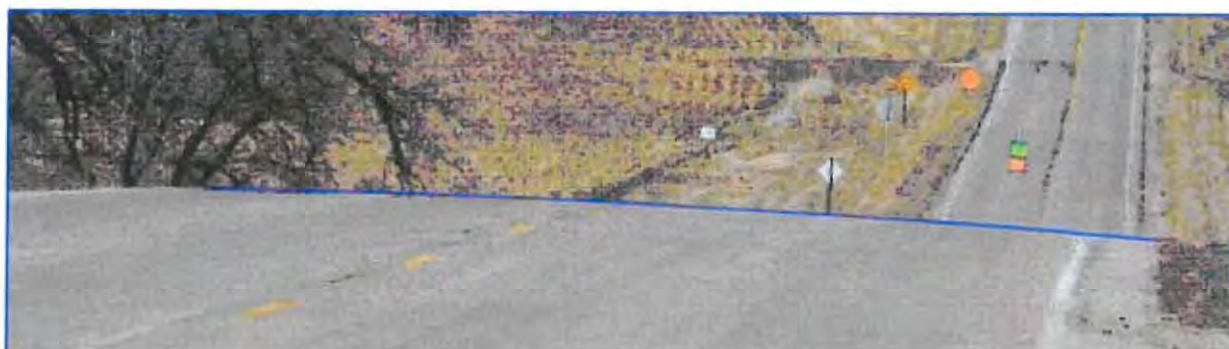
Figure 36b – close-up view of vertical marker

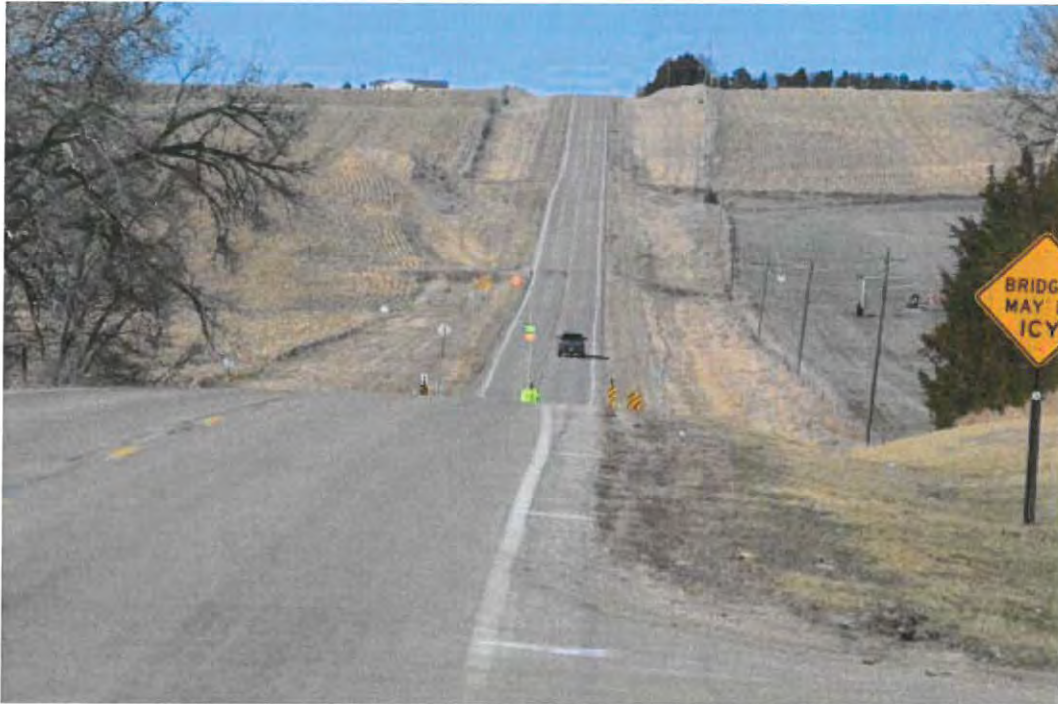
Figure 37 – view of vertical pole from approximately 700 feet from intersection

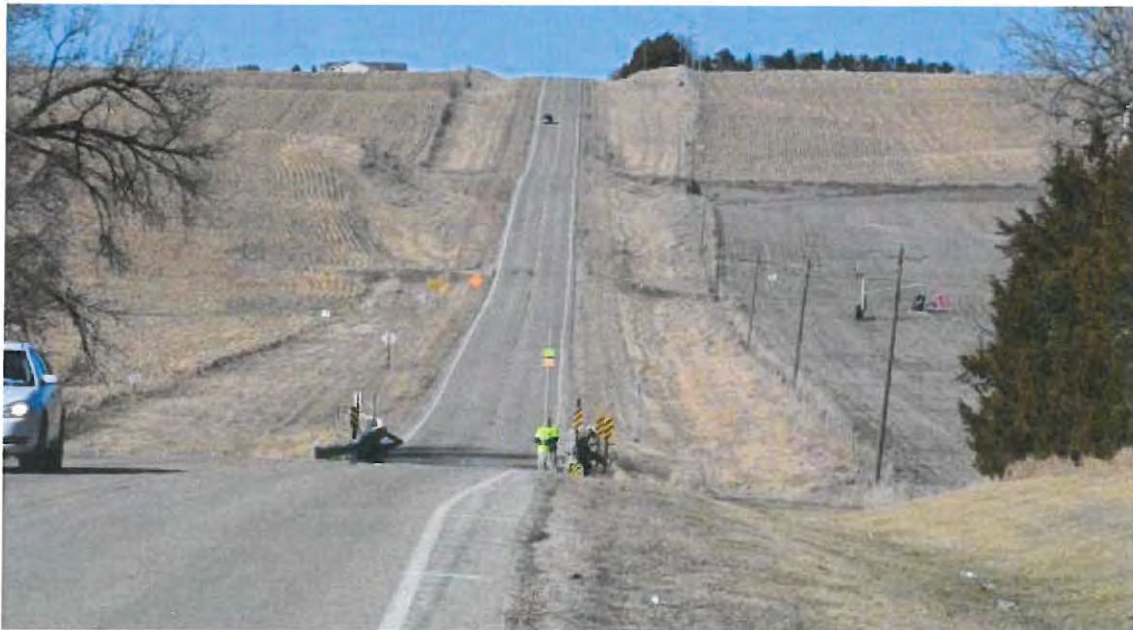
Figure 38- view toward intersection from approximately 600 feet away

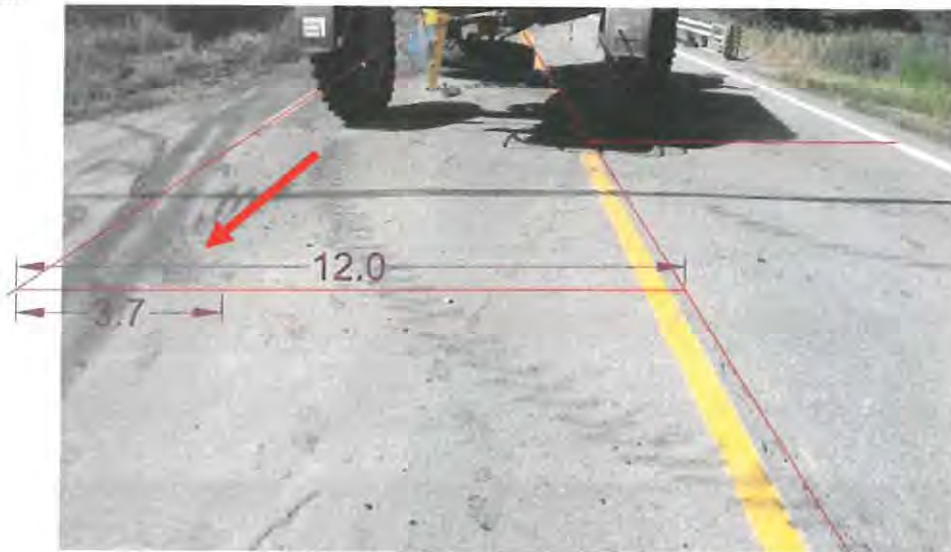
The forensic analysis of the collision also involved an assessment of the interaction between the AGCO farm implement and the Kenworth truck tractor. Photogrammetrically evaluated positioning of the two vehicles at the time of the collision, based upon numerous photographic images taken by the Wayne County Sheriff Department, placed the area of impact for this collision approximately 3.7 feet east of the west fog/lane limit line on Highway 57. That impact area would place the right-front corner of the Kenworth® W900 truck tractor striking the left front wheel of the RoGator® farm implement.

Figure 39 – area of collision

The beginning of the collision scrub mark, as well as the curvilinear tire pattern emanating from the initiating tire mark, can be viewed within Figure 39. Due to the eccentric nature of the collision interaction, the RoGator® implement underwent a counter-clockwise rotational movement toward the northeast. Other tire marks, with the distinctive dual-diagonal tractor-style print, can be easily detected. The right-rear and left-rear tire mark transfers from the RoGator®'s rear axle can be easily viewed, with their distinctive curvilinear pattern.
